**Flood Control Project Maintenance
Levee Inspections**
LMA District Cover Sheet
Spring 2018 Levee Inspection Results

Reclamation District No. 1500 Sutter Basin

Spring 2018 Levee Inspection Results

Waterway			Bank	Unit Miles
Unit No. 01 Sacramento River			Left	33.15
	Spring (March - May)	Summer (June - August)	(September - November) Fall	Winter (December - February)
Unit Maintenance Rating (Fall Only)				
Date of Inspection	3/27/2018 - 3/28/2018			
DWR Inspector	Zach Jojola			
Accompanied By	Hiromi Tomita RD 1500

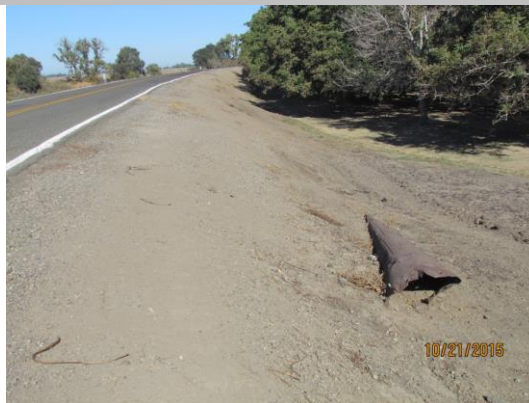
Photo 1 of 1 : SP_2018_RD1500_189_109_20180306_00056.jpg

LM Start	8.79	Rating **	M	Issue No.	109
LM End	8.79	Issue Type +	En	Location *	LS
Category	Earthen Levee			GPS Latitude/Longitude	
				Start	End
Item	Encroachments			38.843481 °	38.843481 °
				-121.727256 °	-121.727256 °
DWR ID	DWR_RD1500_01_f_2017_109				
Comment Code					
DE : Debris					
Inspector Comment					
Abandoned pipe is embedded into levee slope.

View of the abandoned pipe on the landward side of the levee looking upstream. Fall 2015.

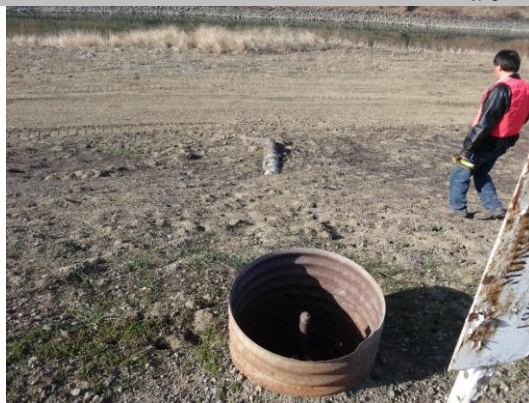
Photo 1 of 3 : UCIP_SP_2018_28363_52167.jpg

Comment Code					
Inspector Comment					
FS_ID:28363 DS_ID:20055 EP_NO: 8503 Repair Type: Non-Urgent Crossing Status: Found UCIP Comments: Looks abandoned. No pump found on WS.New well near landside.May need proper abandonment.Exposed pipe on waterside. Found steel plate closed pipe on landside. FIELD_STRUCT_DESC: *ABANDONED* 12-inch steel irrigation discharge pipe through the levee, 3.8 feet below the crown. Pump on concrete pad with headwall at the riverbank. Siphon breaker in a 24-inch corrugated metal pipe (CMP) riser on the waterside (WS) slope. 1.25-inch conduit through the levee, 3 feet below the crown. Meter pole with switch panel at the landside (LS) toe. Concrete distribution box at the LS toe. (12-inch steel irrigation discharge pipe through the levee and slant pump retained under Permit No. 8503, 1972 - James T. Munson). [Additional Reference(s): DWR Levee Log, 2005. USACE Sacramento O&M Manual 128, March 1960, (HLM 9.04), 10-inch pipe referenced]. FS Date: 1/10/2014

WS view: siphon breaker in CMP riser on levee slope.

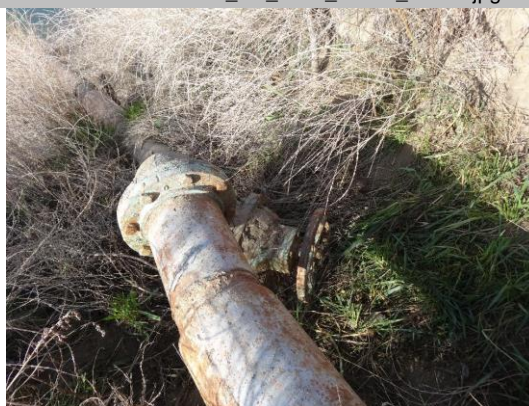
Photo 2 of 3 : UCIP_SP_2018_28363_52166.jpg

WS view: inlet steel pipe with gate valve on river bank.

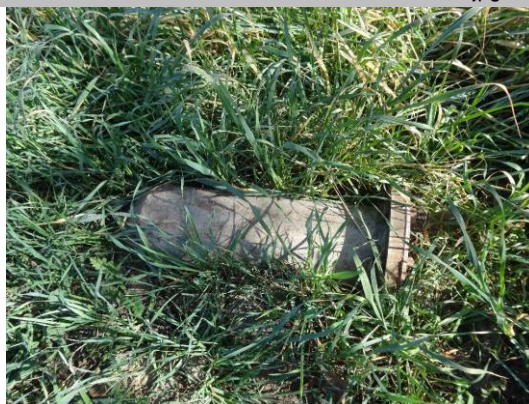
Photo 3 of 3 : UCIP_SP_2018_28363_52165.jpg

LS view: pipe end capped with steel plate on levee toe. Looks abandoned.

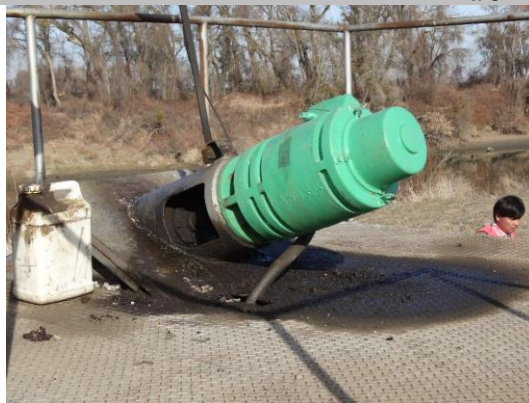
Photo 1 of 3 : UCIP_SP_2018_28364_52174.jpg

Comment Code						
Inspector Comment						
FS_ID:28364 DS_ID:20056 EP_NO: 5598 Repair Type: Non-Urgent Crossing Status: Found UCIP Comments: Not found- Wood headwall 18 ft from landward toe. Not found- Flap gate on landward side.No outlet structure found. Only a capped pipe found, but not sure whether it is connected to the crossing. FIELD_STRUCT_DESC: 12-inch steel irrigation discharge pipe and electrical conduit through the levee, 4.8 feet below the crown. One metal cutoff wall. Slant pump on steel structure on the berm. Siphon breaker in an 8.5-inch steel pipe riser on the landside (LS) shoulder. Meter pole on the LS toe. Wooden headwall with flap gate off the LS toe. Pipe discharges into field. Installed in 1967. (Construction of a pumping plant and installation of a discharge pipe through the levee authorized under Permit No. 5598, 1966 - Arthur C. James Jr. Existing encroachments retained under Permit No. 8505, 1972 - Arthur C. James Jr.). [Additional Reference(s): DWR Levee Log, 2005]. FS Date: 1/10/2014

WS view: slant pump on steel platform on levee berm. Excessive oil leak from the pump.

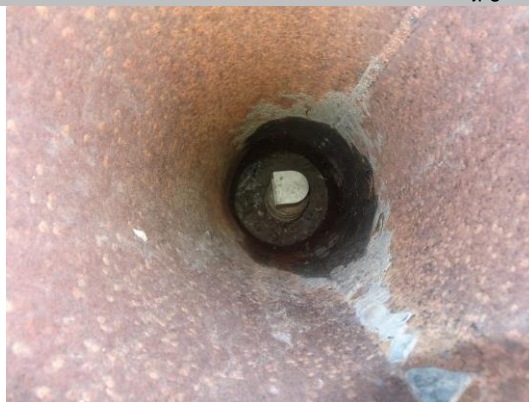
Photo 2 of 3 : UCIP_SP_2018_28364_52175.jpg

LS view: air vent in steel pipe riser on levee slope.

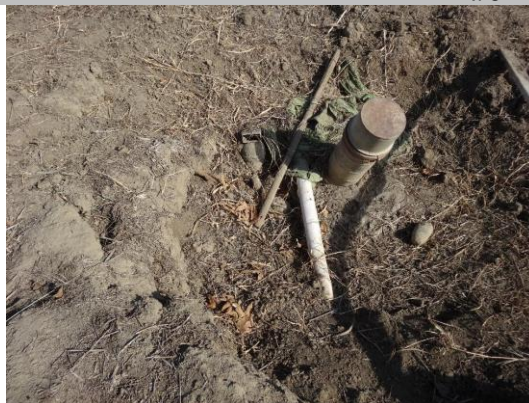
Photo 3 of 3 : UCIP_SP_2018_28364_52173.jpg

Comment Code					
Inspector Comment					
FS_ID:28364 DS_ID:20056 EP_NO: 5598 Repair Type: Non-Urgent Crossing Status: Found UCIP Comments: Not found- Wood headwall 18 ft from landward toe. Not found- Flap gate on landward side.No outlet structure found. Only a capped pipe found, but not sure whether it is connected to the crossing. FIELD_STRUCT_DESC: 12-inch steel irrigation discharge pipe and electrical conduit through the levee, 4.8 feet below the crown. One metal cutoff wall. Slant pump on steel structure on the berm. Siphon breaker in an 8.5-inch steel pipe riser on the landside (LS) shoulder. Meter pole on the LS toe. Wooden headwall with flap gate off the LS toe. Pipe discharges into field. Installed in 1967. (Construction of a pumping plant and installation of a discharge pipe through the levee authorized under Permit No. 5598, 1966 - Arthur C. James Jr. Existing encroachments retained under Permit No. 8505, 1972 - Arthur C. James Jr.). [Additional Reference(s): DWR Levee Log, 2005]. FS Date: 1/10/2014

LS view: capped outlet pipe on levee toe.

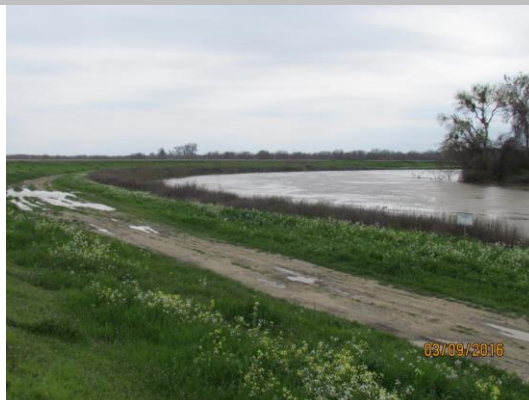
Photo 1 of 2 : SP_2018_RD1500_189_74_20180306_00041.jpg

LM Start	9.40	Rating **	A/W	Issue No.	74
LM End	9.57	Issue Type +	Ma	Location *	WS
Category	Earthen Levee			GPS Latitude/Longitude	
				Start	End
Item	Vegetation			38.850267 °	38.852564 °
				-121.723275 °	-121.723179 °
DWR ID	DWR_RD1500_01_s_2012_74				
Comment Code					
V8 : Environmental Requirements.					
Inspector Comment

View of the revegetation site along the edge of the berm on the waterward side of the levee looking downstream. Spring 2016.

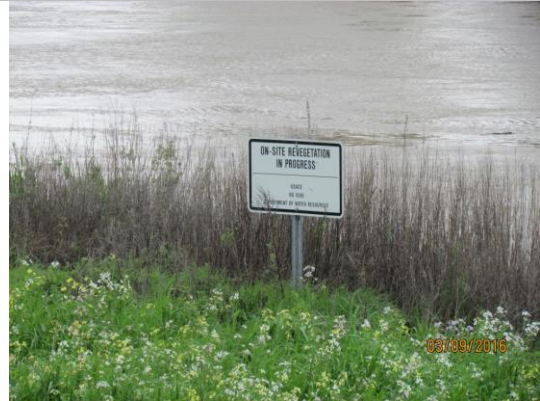
Photo 2 of 2 : SP_2018_RD1500_189_74_20180306_00042.jpg

Sign for the revegetation site by USACE.

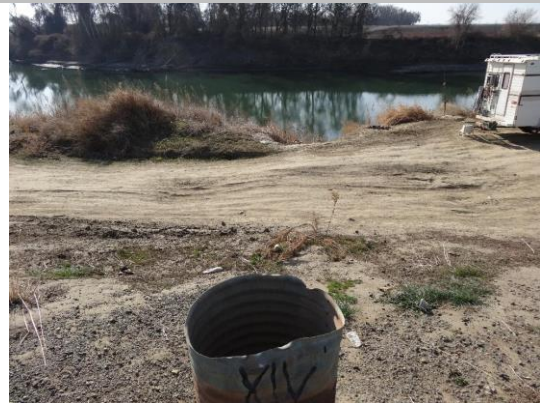
Photo 1 of 3 : UCIP_SP_2018_28365_52182.jpg

Comment Code						
Inspector Comment						
FS_ID:28365 DS_ID:20057 EP_NO: N/A Repair Type: Non-Urgent Crossing Status: Found UCIP Comments: Looks abandoned. Pump has been removed. No outlet pipe found. Not found- Wooden service panel and 3x5 foot concrete distribution box at landward shoulder.May need proper abandonment. FIELD_STRUCT_DESC: 14-inch steel irrigation discharge pipe through the levee, 4.2 feet below the crown. Pump and gate valve on a concrete pump platform on the bank. Siphon breaker in a 24-inch corrugated metal pipe (CMP) riser on the waterside (WS) shoulder. Wooden switch panel and pole on the WS slope. 3-foot by 5-foot concrete distribution box at the landside (LS) toe. (14-inch steel irrigation discharge pipe through the levee, pump, and all other appurtenances retained under Automatic Board Order (ABO) issued as Permit No. 10069, 1974 - Robert Reel). [Additional Reference(s): DWR Levee Log, 2005. USACE Sacramento O&M Manual 128, March 1960, (HLM 9.77)]. FS Date: 1/10/2014

WS view: CMP riser with siphon breaker on levee slope.

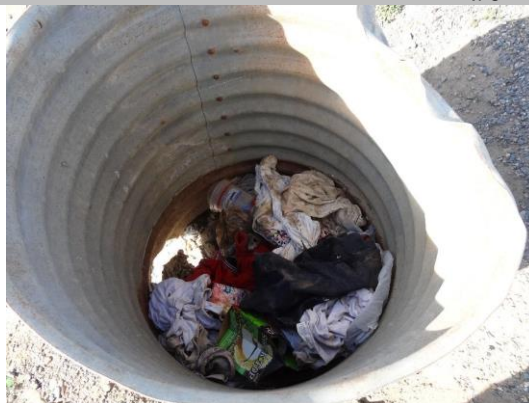
Photo 2 of 3 : UCIP_SP_2018_28365_52180.jpg

WS view: siphon breaker obstructed by dumped-trash in CMP riser.

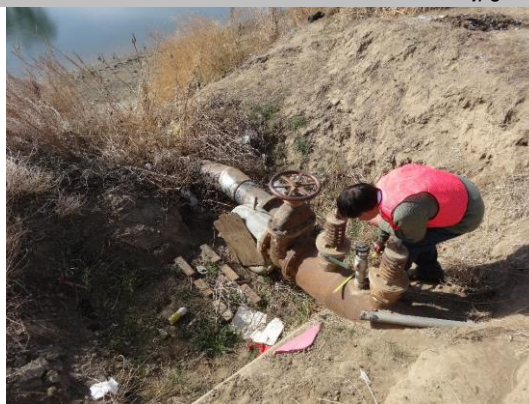
Photo 3 of 3 : UCIP_SP_2018_28365_52179.jpg

LS view: U type concrete headwall, pipe, gate valve, and pump (removed and plugged with plywood) on river bank.

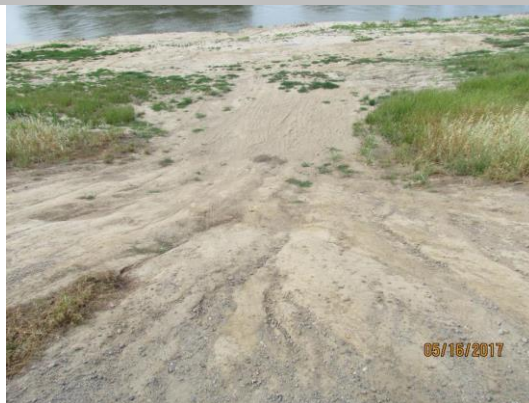
Photo 1 of 1 : SP_2018_RD1500_189_162_20180306_00080.jpg

LM Start	9.71	Rating **	A/W	Issue No.	162
LM End	9.71	Issue Type +	Ma	Location *	WS
Category	Earthen Levee			GPS Latitude/Longitude	
				Start	End
Item	Slope Stability			38.853564 °	38.853564 °
				-121.725379 °	-121.725379 °
DWR ID	DWR_RD1500_01_s_2017_162				
Comment Code					
S3 : Repair the levee slope damaged by vehicle traffic and prevent access where possible.					
Inspector Comment					
Area heavily accessed by homeless and fishermen. Recommend monitoring.

View of slope stability on waterside slope. Spring 2017.

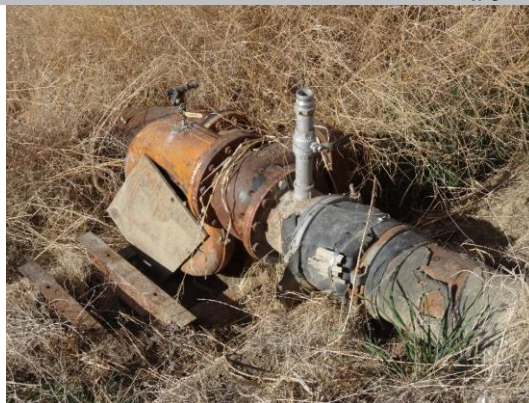
Photo 1 of 3 : UCIP_SP_2018_50069_52188.jpg

Comment Code						
Inspector Comment						
FS_ID:50069 DS_ID:20058 EP_NO: 10068 Repair Type: Non-Urgent Crossing Status: Found UCIP Comments: 01/10/2014Surface erosion along pipe alignment on landside.30-inch concrete pipe in CMP riser on waterside. 30-inch x 24-inch concrete culvert on landside. FIELD_STRUCT_DESC: 24-inch by 30-inch reinforced concrete box irrigation discharge culvert diagonally through the levee, 13 feet below the crown. Two concrete cutoff walls. Slant pump on the riverbank. Slide gate in a 40-inch by 40-inch concrete surge box on the berm. Power pole and switch panel on the waterside (WS) slope. Concrete distribution box at the landside (LS) toe. Installed by Reclamation District No. 1500 in 1920. (24-inch by 30-inch reinforced concrete box irrigation discharge culvert diagonally through the levee, slant pump, and all other appurtenances retained under Automatic Board Order (ABO) issued as Permit No. 10068, 1974 - Cecil Reel). [Additional Reference(s): DWR Levee Log, 2005. USACE Sacramento O&M Manual 128, March 1960, (HLM 10.22)]. FS Date: 1/10/2014

WS view: pipe and pump with appurtenances on river bank. Pump removed and plugged with plywood.

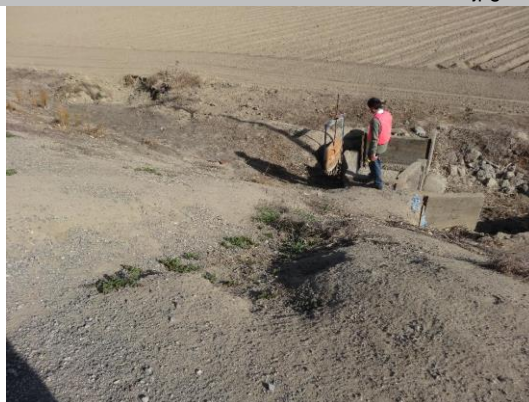
Photo 2 of 3 : UCIP_SP_2018_50069_52189.jpg

LS view: surface erosion along pipe alignment on landside.

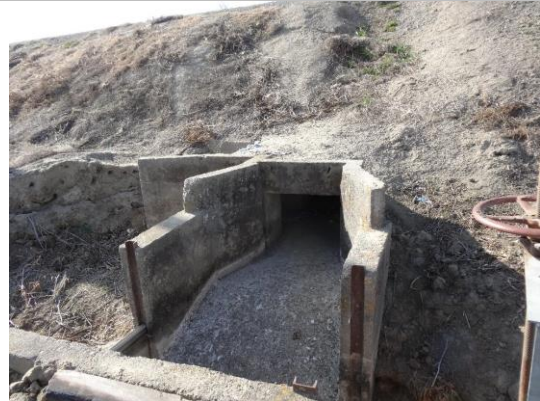
Photo 3 of 3 : UCIP_SP_2018_50069_52192.jpg

LS view: outlet of concrete box culvert on levee toe.

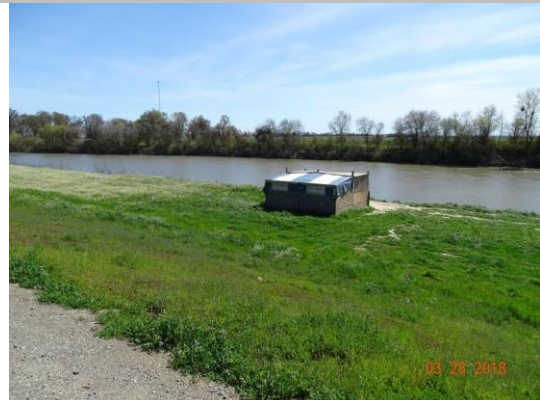
Photo 1 of 1 : SP_2018_RD1500_189_124_20180329_00237.jpg

LM Start	10.61	Rating **	M	Issue No.	124
LM End	10.61	Issue Type +	En	Location *	WS
Category	Earthen Levee			GPS Latitude/Longitude	
				Start	End
Item	Encroachments			38.861171 °	38.861171 °
				-121.735337 °	-121.735337 °
DWR ID	DWR_RD1500_01_s_2018_124				
Comment Code					
BU : Building					
Inspector Comment					
Fishing shack on waterside berm.

View of fishing strucure on waterside berm. Spring 2018.

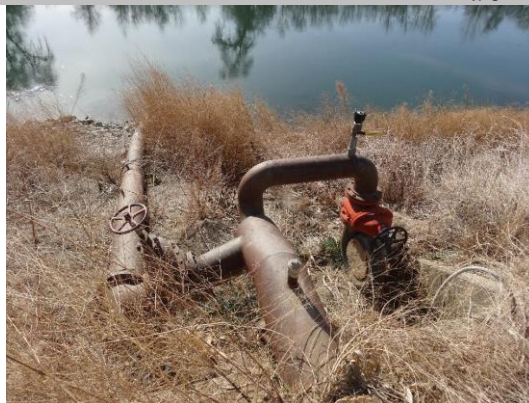
Photo 1 of 3 : UCIP_SP_2018_28925_53210.jpg

Comment Code					
Inspector Comment					
FS_ID:28925 DS_ID:20059 EP_NO: N/A Repair Type: Non-Urgent Crossing Status: Found UCIP Comments: Pump removed.Obstructed siphon breaker in CMP riser on landside. FIELD_STRUCT_DESC: 12-inch steel irrigation discharge pipe through the levee, 4.3 feet below the crown. One cutoff wall. 1.5-inch conduit through the levee, 2 feet below the crown. Slant type centrifugal pumping plant on the riverbank removed during the winter months and a steel plate is bolted to the end of the pipe. Gate valve on the waterside (WS). Siphon breaker in a 24-inch corrugated metal pipe (CMP) riser on the landside (LS) shoulder. 8-foot by 6-foot, inside measurements, concrete distribution box and meter pole with switch panel at the LS toe. (12-inch steel irrigation discharge pipe through the levee and slant type centrifugal pumping plant retained under Permit No. 8506, 1972 - Eugene C. Reel et al.). [Additional Reference(s): DWR Levee Log, 2005. USACE Sacramento O&M Manual 128, March 1960, (HLM 10.81)]. FS Date: 1/10/2014

WS view: pipe, pump (removed and plugged with plywood), headwall, and appurtenances on river bank.

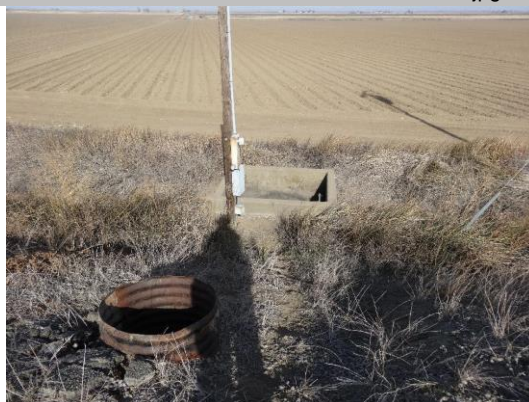
Photo 2 of 3 : UCIP_SP_2018_28925_53209.jpg

LS view: siphon breaker in CMP riser (bottom) on levee slope and concrete distribution box (top) on levee toe.

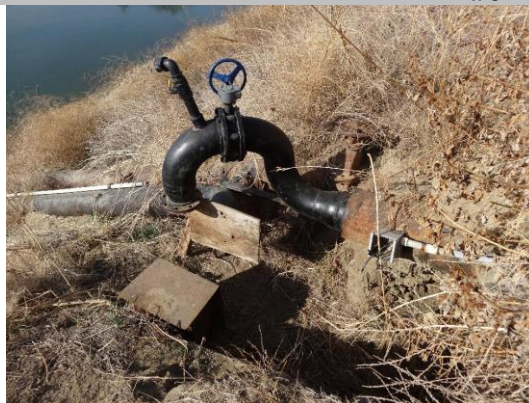
Photo 1 of 3 : UCIP_SP_2018_50043_52213.jpg

Comment Code						
Inspector Comment						
FS_ID:50043 DS_ID:20060 EP_NO: 10068 Repair Type: Urgent Crossing Status: Found UCIP Comments: 08/29/2016 Pot hole in alignment with pipe is still present on levee crown. Sloughing of LS slope is in alignment with pipe. Permit underway for installation of new pipe so urgent category will soon be corrected. Siemens service pole may be unauthorized. Otherwise same as last inspection.01/10/2014 Pump removed.10-inch pipe joined to 14-inch pipe.Wet, some vegetations, and subsidence along pipe alignment on landside. This needs detailed investigation. FIELD_STRUCT_DESC: 14-inch steel irrigation discharge pipe through the levee, 4.7 feet below the crown. One corrugated metal cutoff wall. Pump and gate valve on a concrete platform on the riverbank. Pump house on the waterside (WS) slope. Switch control house and new Siemens meter pole on the WS shoulder. Siphon breaker in a 24-inch corrugated metal pipe (CMP) riser on the landside (LS) shoulder. Concrete distribution box on the LS. Installed by USACE in 1952. (14-inch steel irrigation discharge pipe through the levee, pump, and all other appurtenances retained under Automatic Board Order (ABO) issued as Permit No. 10068, 1974 - Cecil Reel). [Additional Reference(s): DWR Levee Log, 2005. USACE Sacramento O&M Manual 128, March 1960, (HLM 11.35)]. FS Date: 8/29/2016

WS view: pipe, pump (removed and plugged with plywood plate), and appurtenances on river bank.

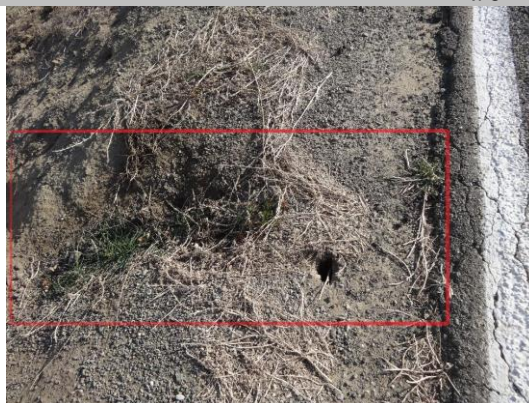
Photo 2 of 3 : UCIP_SP_2018_50043_52212.jpg

LS view: wet, some vegetations, and subsidence along pipe alignment on landside.

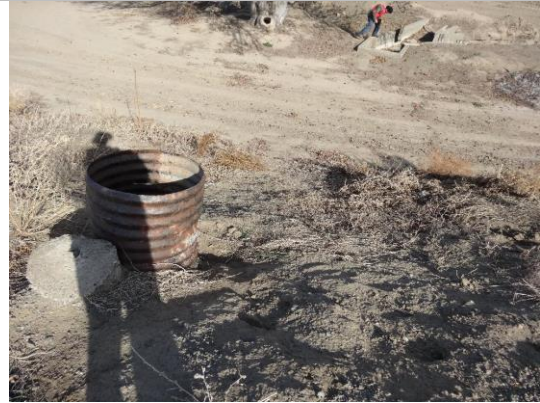
Photo 3 of 3 : UCIP_SP_2018_50043_52211.jpg

LS view: siphon breaker in CMP riser on levee slope and concrete distribution box on levee toe (top0).

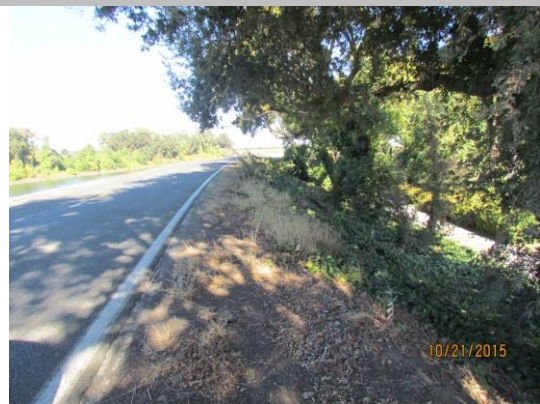
Photo 1 of 1 : SP_2018_RD1500_189_20_20180306_00017.jpg

LM Start	11.30	Rating **	M	Issue No.	20
LM End	11.30	Issue Type +	En	Location *	LS
Category	Earthen Levee			GPS Latitude/Longitude	
				Start	End
Item	Vegetation			38.866383 °	38.866383 °
				-121.745911 °	-121.745911 °
DWR ID	DWR_RD1500_01_s_2012_20				
Comment Code					
V6 : Landscaping					
Inspector Comment					
Permitted landscape needs maintenances (PN: 10041)

View of the landscaping on the landward side of the levee looking upstream. Fall 2015.

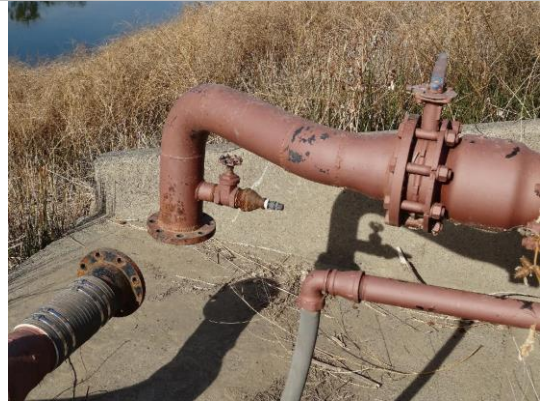
Photo 1 of 3 : UCIP_SP_2018_50198_52220.jpg

FS_ID:50198
DS_ID:20061
EP_NO: 10041
Repair Type: Non-Urgent
Crossing Status: Found
UCIP Comments: 08/29/2016 Depressions cited previously are a make-shift staircase and not an indication of a problem with pipe. Pipe partially exposed on LS slope which should be backfilled. Crossing has been downgraded from Urgent to Non-Urgent. (K. Fazel - UCIP)01/10/2014 Depressions on both sides of the levee slope. It needs more investigation. Pump removed. (P. Amatya - DWR)
FIELD_STRUCT_DESC: 8-inch steel irrigation discharge pipe through the levee, 4 feet below the crown. One corrugated metal cutoff wall. Pump and gate valve on a concrete pump platform on the riverbank. Corrugated metal switch house on the waterside (WS) slope. Meter pole on the WS shoulder. 8-foot by 6-foot, inside dimensions, concrete distribution box on the landside (LS). Overhead power line crosses the levee. Pole at the LS toe. Installed by USACE in 1952. (8-inch steel irrigation discharge pipe through the levee, pump, and all other appurtenances retained under Automatic Board Order (ABO) issued as Permit No. 10041, 1974 - William J. Duffy Jr.) [Additional Reference(s): DWR Levee Log, 2005. USACE Sacramento O&M Manual 128, March 1960, (HLM 11.57)].

WS view: pipe, pump (removed), headwall, and appurtenances on river bank.

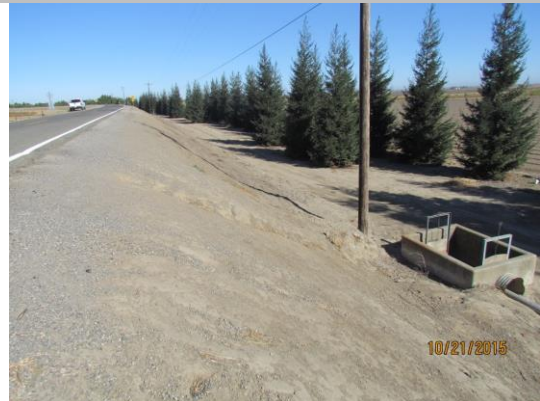
Photo 1 of 3 : SP_2018_RD1500_189_114_20180306_00058.jpg

LM Start	11.45	Rating **	A/W	Issue No.	114
LM End	11.45	Issue Type +	Ma	Location *	LS
Category	Earthen Levee			GPS Latitude/Longitude	
				Start	End
Item	Slope Stability			38.868577 °	38.868577 °
				-121.746487 °	-121.746487 °
DWR ID	DWR_RD1500_01_f_2015_114				
Comment Code					
S2 : Repair the levee slope damaged by foot traffic and prevent access where possible.					
Inspector Comment					
The previous stairs in the photos have been filled in, but the slope remains an active access ramp. Recommend monitoring.

Perspective view of the concrete box on the landward side of the levee looking upstream. Fall 2015.

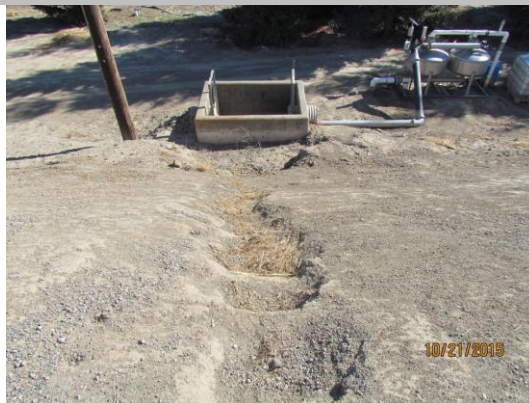
Photo 2 of 3 : SP_2018_RD1500_189_114_20180306_00059.jpg

LM Start	11.45	Rating **	A/W	Issue No.	114 (cont)	
LM End	11.45	Issue Type +	Ma	Location *	LS	
Category	Earthen Levee			GPS Latitude/Longitude		
				Start		End
Item	Slope Stability			38.868577 °		38.868577 °
				-121.746487 °		-121.746487 °
DWR ID	DWR_RD1500_01_f_2015_114					
Comment Code						
S2 : Repair the levee slope damaged by foot traffic and prevent access where possible.						
Inspector Comment						
The previous stairs in the photos have been filled in, but the slope remains an active access ramp. Recommend monitoring.

There is erosion at the levee toe around the concrete box. There are also stairs leading down the slope. Fall 2015.

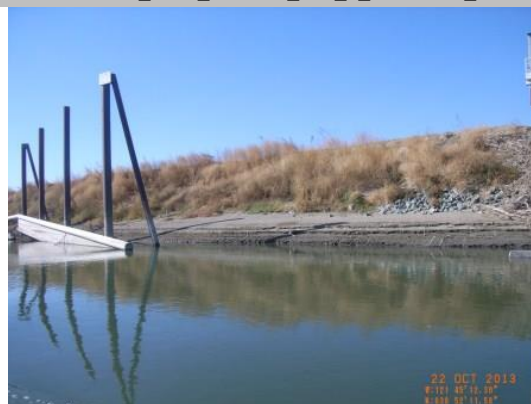
Photo 1 of 1 : SP_2018_RD1500_189_1_20180306_00001.jpg

LM Start	11.99	Rating **	A/W	Issue No.	1
LM End	12.26	Issue Type +	Ma	Location *	WS
Category	Supplemental			GPS Latitude/Longitude	
				Start	End
Item	2015 USACE Erosion Survey, DRAFT			38.870474 °	38.869139 °
				-121.752237 °	-121.757108 °
DWR ID	DWR_RD1500_01_s_2016_1				
Comment Code					
Inspector Comment					
2000 - Vertical Modesto Formation bank with mass failure. 2003 - Upstream end has some new bank retreat. 2004 - Upstream end is worse. 2006 - Some new erosion, mainly on the steep slope and scarps. (Pumping station is not part of the erosion site.) 2010 - Some new erosion and deposition at upstream end, definite encroachments. 2011 - Minor new erosion at the toe. 2015: Site removed, sufficient berm width. [2015 Site ID: SAC_96-2_L]

USACE 2013 Photo #1

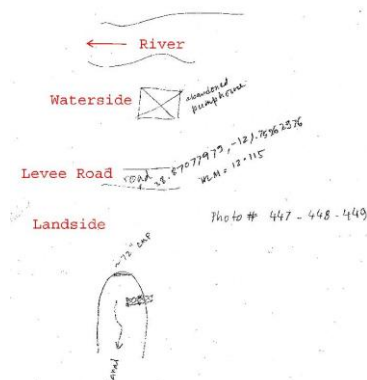
Photo 1 of 3 : UCIP_SP_2018_41744_51343.jpg

FS_ID:41744
DS_ID:20008
EP_NO: N/A
Repair Type: Non-Urgent
Crossing Status: Indicator Found
UCIP Comments: An abandoned pump house on waterside and a 72-inch corrugated metal pipe on landside. The pipe discharges into irrigation ditch (canal). Water was flowing during the field visit. Needs to verify from LMA whether this pipe is through the levee or not.
FIELD_STRUCT_DESC: [State Ranch Bend Pumping Plant] 1 of 2: 36-inch by 42-inch reinforced concrete irrigation discharge culvert under the levee, 17 feet below the crown. Two concrete cutoff walls. Vertical pump on the riverbank. Slide gate on the waterside (WS) end. Wooden slide gate at the landside (LS) toe. Installed by USACE in 1947. (36-inch by 42-inch reinforced concrete irrigation discharge culvert under the levee, vertical pump, and all other appurtenances retained under Automatic Board Order (ABO) issued as Permit No. 10073, 1974 - Sutter Mutual Water Company, [Station 356+02]. To comply with Condition No. TWENTY of Board Order No. 9809 with plans to remove the old Pumping Plant No. 1 authorized under Permit No. 9809-A, 1976 - Sutter Mutual Water Company). [Additional Reference(s): DWR Levee Log, 1990. USACE Sacramento O&M Manual 128, March 1960, (HLM 12.12), two 48-inch by 42-inch concrete culverts referenced].

Sketch of Utility Crossing @HLM 12.115

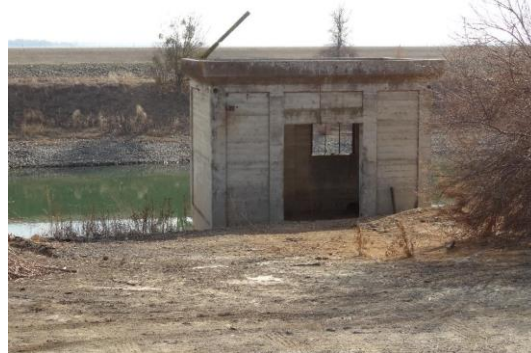
Photo 2 of 3 : UCIP_SP_2018_41744_51345.jpg

WS view: abandoned concrete pump house. No pump and pipe found.

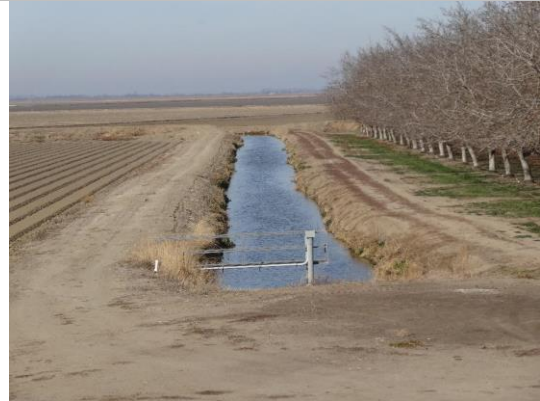
Photo 3 of 3 : UCIP_SP_2018_41744_51344.jpg

LS view: overview of irrigation ditch on toe of levee.

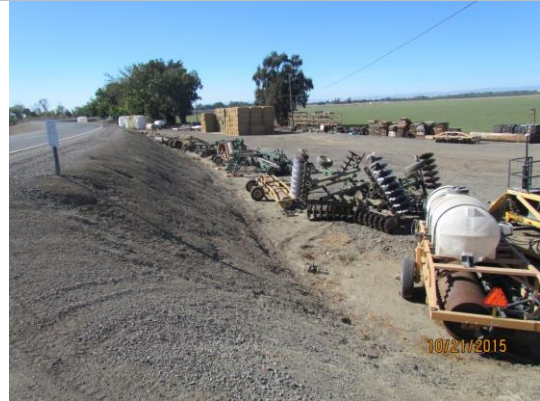
Photo 1 of 1 : SP_2018_RD1500_189_24_20180306_00021.jpg

LM Start	12.42	Rating **	M	Issue No.	24
LM End	12.53	Issue Type +	En	Location *	LS
Category	Earthen Levee			GPS Latitude/Longitude	
				Start	End
Item	Encroachments			38.868834 °	38.867492 °
				-121.760014 °	-121.760903 °
DWR ID	DWR_RD1500_01_s_2012_24				
Comment Code					
EQ : Equipment					
Inspector Comment

View of the equipment on the landward side of the levee looking upstream. Fall 2015.

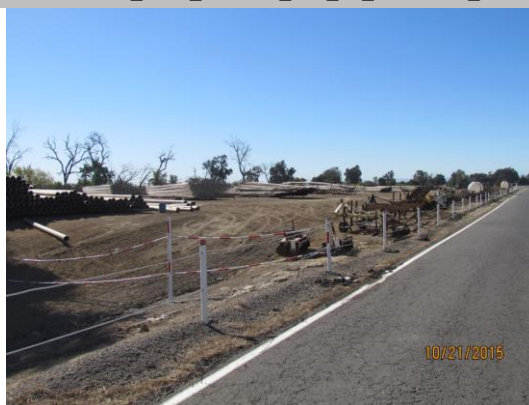
Photo 1 of 1 : SP_2018_RD1500_189_25_20180306_00022.jpg

LM Start	12.78	Rating **	M	Issue No.	25
LM End	12.86	Issue Type +	En	Location *	CR
Category	Earthen Levee			GPS Latitude/Longitude	
				Start	End
Item	Encroachments			38.865429 °	38.864777 °
				-121.764684 °	-121.765857 °
DWR ID	DWR_RD1500_01_s_2012_25				
Comment Code					
EQ : Equipment					
Inspector Comment

View of the equipment on the crown of the levee looking upstream. Fall 2015.

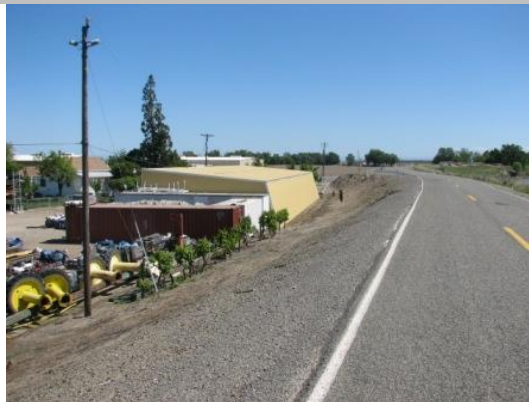
Photo 1 of 1 : SP_2018_RD1500_189_26_20180306_00023.jpg

LM Start	13.01	Rating **	M	Issue No.	26
LM End	13.01	Issue Type +	En	Location *	LS
Category	Earthen Levee			GPS Latitude/Longitude	
				Start	End
Item	Encroachments			38.863438 °	38.863438 °
				-121.768212 °	-121.768212 °
DWR ID	DWR_RD1500_01_s_2012_26				
Comment Code					
BU : Building					
Inspector Comment

The building's backside was built into the toe of the levee.

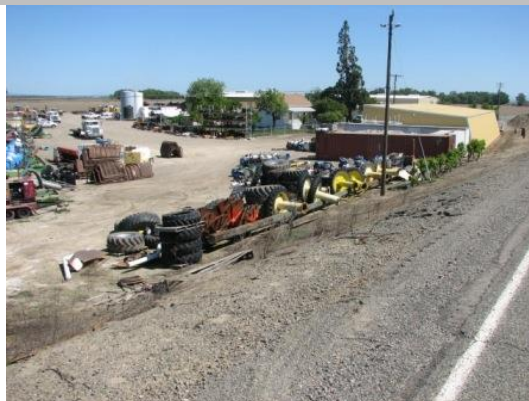
Photo 1 of 1 : SP_2018_RD1500_189_992_20180306_00087.jpg

LM Start	13.05	Rating **	M	Issue No.	992
LM End	13.05	Issue Type +	En	Location *	LS
Category	Earthen Levee			GPS Latitude/Longitude	
				Start	End
Item	Encroachments			38.863081 °	38.863081 °
				-121.768781 °	-121.768781 °
DWR ID	DWR_RD1500_01_s_2012_992				
Comment Code					
EQ : Equipment					
Inspector Comment					
There are equipment and tires at this location.

Next to the building there are tires and axles stored at the toe.

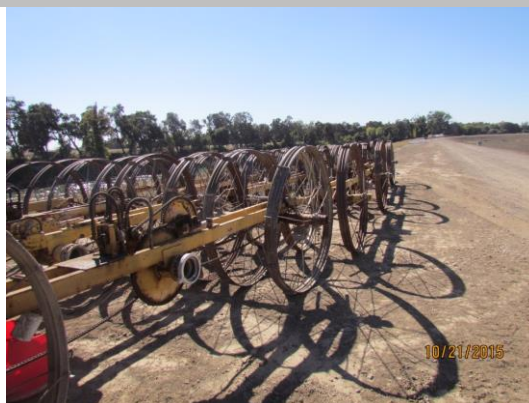
Photo 1 of 1 : SP_2018_RD1500_189_119_20180306_00064.jpg

LM Start	13.78	Rating **	M	Issue No.	119
LM End	13.82	Issue Type +	En	Location *	CR
Category	Earthen Levee			GPS Latitude/Longitude	
				Start	End
Item	Encroachments			38.859679 °	38.859201 °
				-121.780862 °	-121.781276 °
DWR ID	DWR_RD1500_01_f_2015_119				
Comment Code					
EQ : Equipment					
Inspector Comment

View of the equipment on the crown of the levee looking upstream. Fall 2015.

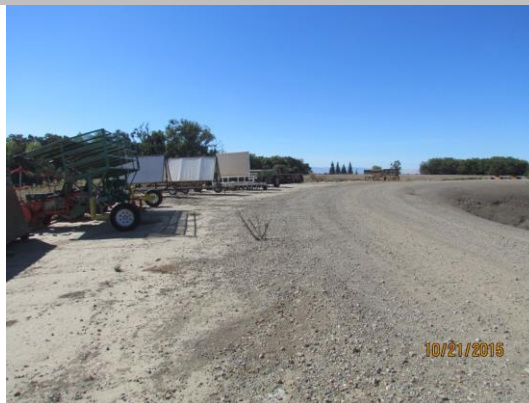
Photo 1 of 1 : SP_2018_RD1500_189_28_20180306_00024.jpg

LM Start	13.96	Rating **	M	Issue No.	28
LM End	13.96	Issue Type +	En	Location *	CR
Category	Earthen Levee			GPS Latitude/Longitude	
				Start	End
Item	Encroachments			38.857625 °	38.857625 °
				-121.782832 °	-121.782832 °
DWR ID	DWR_RD1500_01_s_2012_28				
Comment Code					
EQ : Equipment					
Inspector Comment					
Equipment are on the crown of the levee but does not obstruct access.

View of the equipment on the crown side of the levee looking upstream.
Fall 2015.

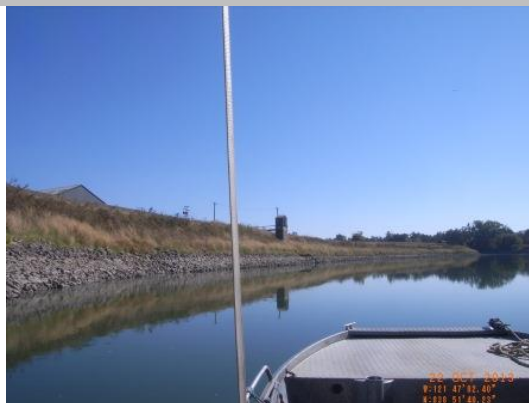
Photo 1 of 1 : SP_2018_RD1500_189_10_20180306_00011.jpg

LM Start	13.98	Rating **	A/W	Issue No.	10
LM End	14.26	Issue Type +	Ma	Location *	WS
Category	Supplemental			GPS Latitude/Longitude	
				Start	End
Item	2015 USACE Erosion Survey, DRAFT			38.857239 °	38.861899 °
				-121.783771 °	-121.784057 °
DWR ID	DWR_RD1500_01_s_2016_10				
Comment Code					
Inspector Comment					
1997 - Intermittent toe failure of the hand placed riprap; failure of toe materials. 2015: No observed changes. [2015 Site ID: SAC_99-0_L]

USACE 2013 Photo #1

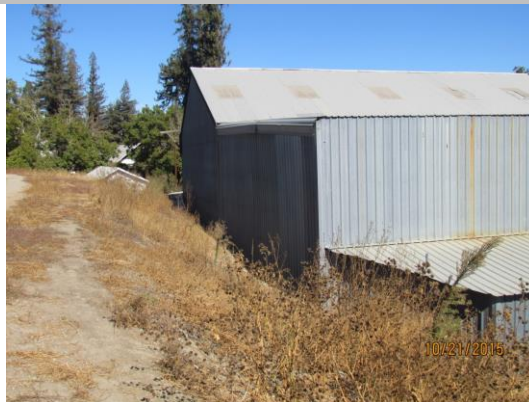
Photo 1 of 1 : SP_2018_RD1500_189_30_20180306_00025.jpg

LM Start	14.19	Rating **	M	Issue No.	30
LM End	14.19	Issue Type +	En	Location *	LS
Category	Earthen Levee			GPS Latitude/Longitude	
				Start	End
Item	Encroachments			38.860624 °	38.860624 °
				-121.783324 °	-121.783324 °
DWR ID	DWR_RD1500_01_s_2012_30				
Comment Code					
BU : Building					
Inspector Comment					
Concrete stemwall into levee embankment.

View of the building on the landward side of the levee looking upstream.
Fall 2015.

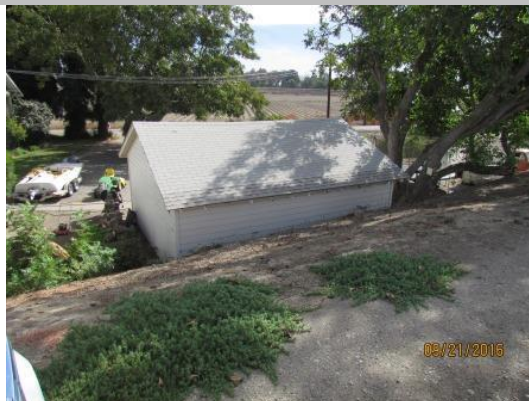
Photo 1 of 1 : SP_2018_RD1500_189_138_20180306_00073.jpg

LM Start	14.21	Rating **	M	Issue No.	138
LM End	14.21	Issue Type +	En	Location *	LS
Category	Earthen Levee			GPS Latitude/Longitude	
				Start	End
Item	Encroachments			38.860951 °	38.860951 °
				-121.783422 °	-121.783422 °
DWR ID	DWR_RD1500_01_f_2016_138				
Comment Code					
BU : Building					
Inspector Comment

View of a building encroaching levee on landside toe. Fall 2016.

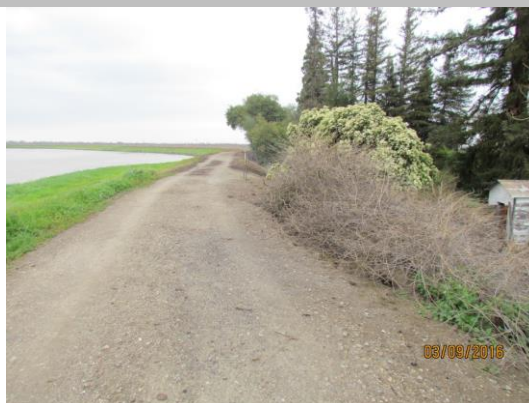
Photo 1 of 1 : SP_2018_RD1500_189_31_20180306_00026.jpg

LM Start	14.24	Rating **	M	Issue No.	31
LM End	14.28	Issue Type +	En	Location *	LS
Category	Earthen Levee			GPS Latitude/Longitude	
				Start	End
Item	Vegetation			38.861335 °	38.861913 °
				-121.783605 °	-121.783751 °
DWR ID	DWR_RD1500_01_s_2012_31				
Comment Code					
V6 : Landscaping					
Inspector Comment

View of the landscaping on the landward side of the levee looking upstream. Spring 2016.

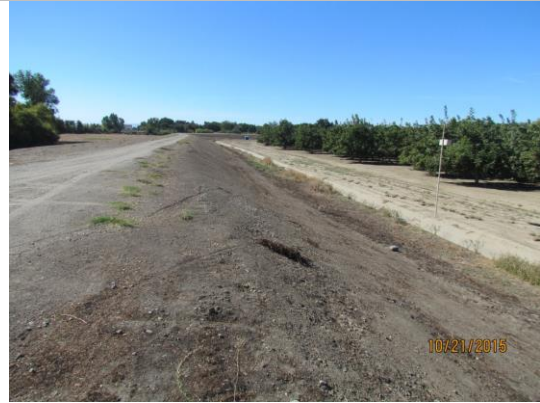
Photo 1 of 1 : SP_2018_RD1500_189_969_20180306_00084.jpg

LM Start	14.71	Rating **	M	Issue No.	969
LM End	15.76	Issue Type +	En	Location *	LS
Category	Earthen Levee			GPS Latitude/Longitude	
				Start	End
Item	Encroachments			38.865395 °	38.871827 °
				-121.789402 °	-121.804158 °
DWR ID	DWR_RD1500_01_s_2012_969				
Comment Code					
DT : Ditch					
Inspector Comment					
Ditch is at the levee toe.

View of the ditch on the landward side of the levee looking upstream.
Fall 2015.

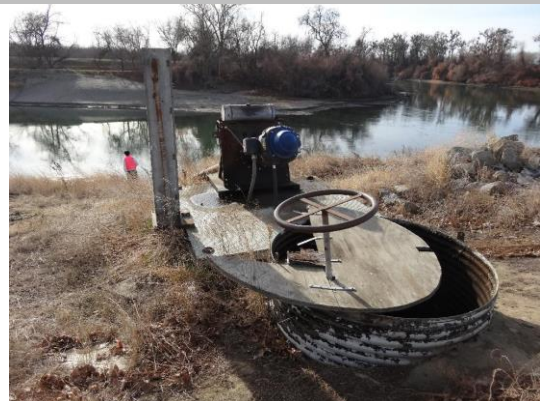
Photo 1 of 3 : UCIP_SP_2018_28486_52461.jpg

Comment Code						
Inspector Comment						
FS_ID:28486 DS_ID:20010 EP_NO: 10037 Repair Type: Non-Urgent Crossing Status: Found UCIP Comments: Water treatment plant on landside.Working during field visit.Not found- Flap Gate in 6.5 foot by 7.0 foot O.D. concrete distribution box at landward toe. FIELD_STRUCT_DESC: 22-inch concrete encased steel irrigation discharge pipe through the levee, 17.5 feet below the crown. One concrete cutoff wall. 1.5-inch conduit through the levee, 6 feet below the crown. Slant pump on the riverbank. Slide gate in a 60-inch corrugated metal pipe (CMP) riser on the waterside (WS) slope. Flap gate in a 6.5-foot by 7-foot, outside dimensions, concrete distribution box at the landside (LS) toe. Meter pole and sparkling water meter in a 22-inch steel riser at the LS toe. (22-inch concrete encased steel irrigation discharge pipe through the levee, slant pump, and all other appurtenances retained under Automatic Board Order (ABO) issued as Permit No. 10037, 1974 - John Clauss). [Additional Reference(s): DWR Levee Log, 1990. USACE Sacramento O&M Manual 128, March 1960, (HLM 15.26), 18-inch pipe referenced]. FS Date: 1/10/2014

WS view: CMP riser with gate valve and slant pump on steel platform.

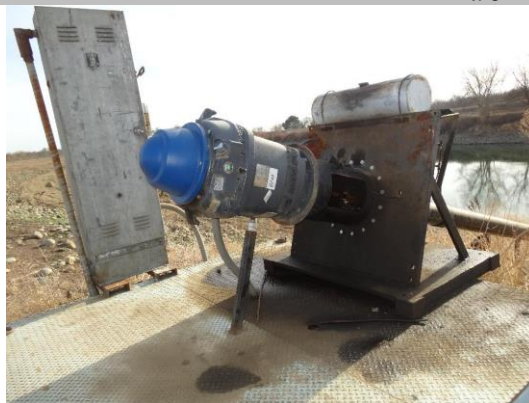
Photo 2 of 3 : UCIP_SP_2018_28486_52460.jpg

Item	DWR UCIP Field Study			38.866841 °	38.866841 °	
				-121.794047 °	-121.794047 °	
DWR ID						
Comment Code						
Inspector Comment						
FS_ID:28486 DS_ID:20010 EP_NO: 10037 Repair Type: Non-Urgent Crossing Status: Found UCIP Comments: Water treatment plant on landside.Working during field visit.Not found- Flap Gate in 6.5 foot by 7.0 foot O.D. concrete distribution box at landward toe. FIELD_STRUCT_DESC: 22-inch concrete encased steel irrigation discharge pipe through the levee, 17.5 feet below the crown. One concrete cutoff wall. 1.5-inch conduit through the levee, 6 feet below the crown. Slant pump on the riverbank. Slide gate in a 60-inch corrugated metal pipe (CMP) riser on the waterside (WS) slope. Flap gate in a 6.5-foot by 7-foot, outside dimensions, concrete distribution box at the landside (LS) toe. Meter pole and sparkling water meter in a 22-inch steel riser at the LS toe. (22-inch concrete encased steel irrigation discharge pipe through the levee, slant pump, and all other appurtenances retained under Automatic Board Order (ABO) issued as Permit No. 10037, 1974 - John Clauss). [Additional Reference(s): DWR Levee Log, 1990. USACE Sacramento O&M Manual 128, March 1960, (HLM 15.26), 18-inch pipe referenced]. FS Date: 1/10/2014

WS view: oil leaking slant pump on steel platform.

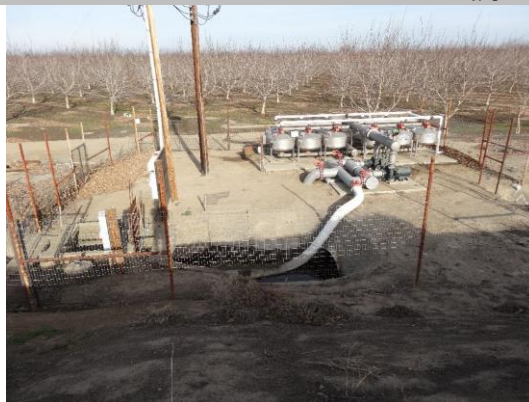
Photo 3 of 3 : UCIP_SP_2018_28486_52459.jpg

LS view: concrete distribution box on levee toe. Water filtration plant off the levee toe.

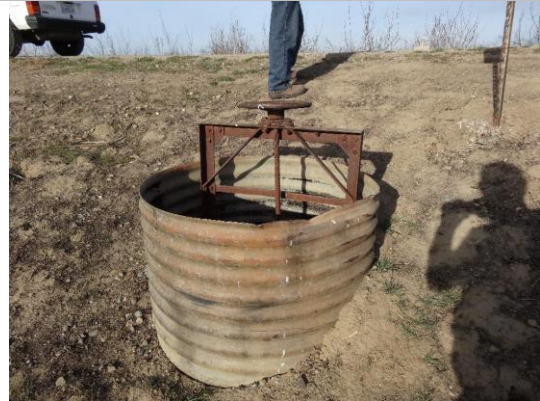
Photo 1 of 3 : UCIP_SP_2018_50196_52467.jpg

Comment Code						
Inspector Comment						
FS_ID:50196 DS_ID:20011 EP_NO: 9337 Repair Type: No Action Needed Crossing Status: Found UCIP Comments: 08/29/2016 As it currently stands, there is no connection to the river, as, according to LMA, this pipe is used for irrigation of WS fields. (K. Fazel - UCIP)01/10/2014 No pipe found on river bank. (P. Amatya - DWR) FIELD_STRUCT_DESC: 24-inch corrugated metal gravity irrigation pipe through the levee, 16 feet below the crown. Slide gate in a 36-inch corrugated metal pipe (CMP) riser on the waterside (WS) slope. Slide gate on a concrete U-shaped headwall at the landside (LS) toe. Per LMA, water is pumped into the LS canal via a LS pump upstream of the crossing. Water then flows through the CMP crossing by gravity for irrigation of WS fields. Permit is forthcoming with Dave Burrows of Winsept Farms as the applicant. (24-inch corrugated metal gravity irrigation pipe through the levee and all other appurtenances retained under Automatic Board Order (ABO) issued as Permit No. 9337, 1973 - Clauss [permit missing]). [Additional Reference(s): DWR Levee Log, 1990. USACE Sacramento O&M Manual 128, March 1960, (HLM 15.89)]. FS Date: 8/29/2016

WS view: CMP riser with slide gate on levee slope.

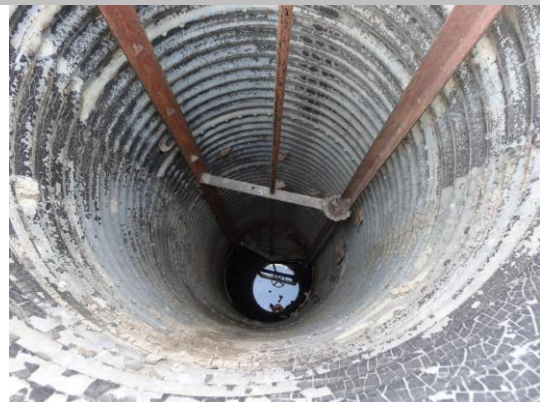
Photo 2 of 3 : UCIP_SP_2018_50196_52466.jpg

WS view: inside view of CMP riser with slide gate.

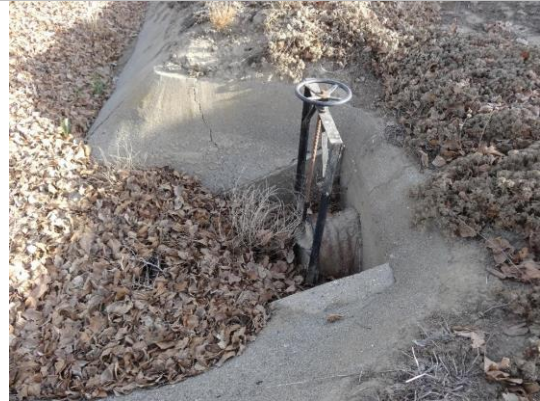
Photo 3 of 3 : UCIP_SP_2018_50196_52465.jpg

LS view: CMP outlet with slide gate and U type headwall on levee toe.

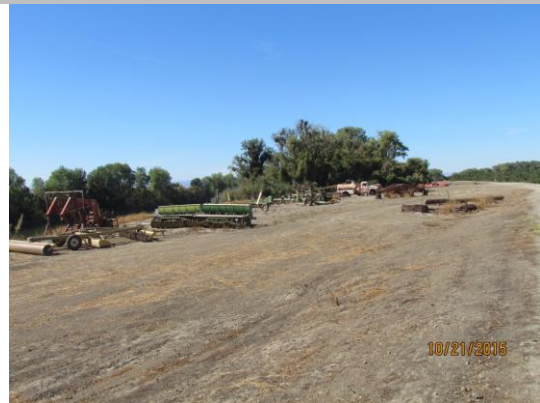
Photo 1 of 1 : SP_2018_RD1500_189_32_20180306_00027.jpg

LM Start	15.76	Rating **	M	Issue No.	32
LM End	15.76	Issue Type +	En	Location *	WS
Category	Earthen Levee			GPS Latitude/Longitude	
				Start	End
Item	Encroachments			38.871828 °	38.871828 °
				-121.804158 °	-121.804158 °
DWR ID	DWR_RD1500_01_s_2017_32				
Comment Code					
EQ : Equipment					
Inspector Comment

View of the equipment on the waterward side of the levee looking upstream. Fall 2015.

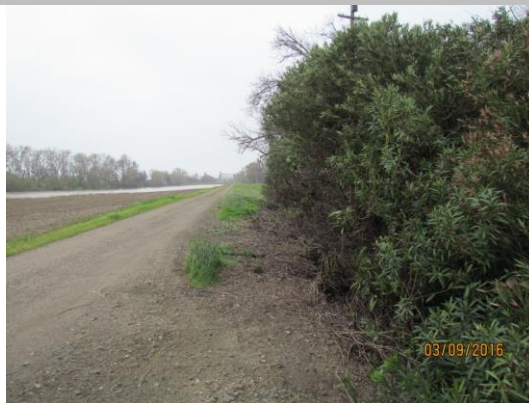
Photo 1 of 1 : SP_2018_RD1500_189_33_20180306_00028.jpg

LM Start	16.30	Rating **	U	Issue No.	33
LM End	16.30	Issue Type +	En	Location *	LS
Category	Earthen Levee			GPS Latitude/Longitude	
				Start	End
Item	Vegetation			38.875785 °	38.875785 °
				-121.812330 °	-121.812330 °
DWR ID	DWR_RD1500_01_f_2017_33				
Comment Code					
V6 : Landscaping					
Inspector Comment

View of the shrubs on the landward side of the levee looking upstream. Spring 2016.

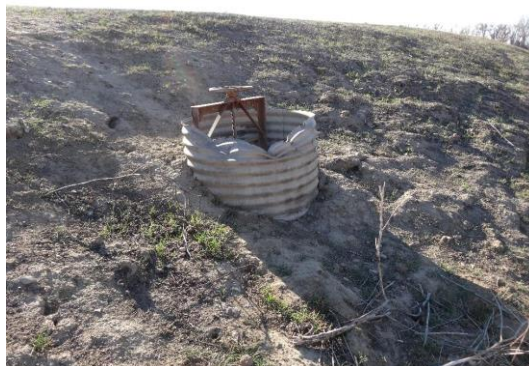
Photo 1 of 3 : UCIP_SP_2018_28489_52479.jpg

Comment Code						
Inspector Comment						
FS_ID:28489 DS_ID:20081 EP_NO: 8510 Repair Type: Non-Urgent Crossing Status: Found UCIP Comments: Pipe not visible on river bank.Cleaning and clearing require around slide gates. May be abandoned. FIELD_STRUCT_DESC: 24-inch corrugated metal irrigation discharge pipe through the levee, 15 feet below the crown. Slide gate in a 36-inch corrugated metal pipe (CMP) riser on the waterside (WS) slope. Slide gate on a concrete U-shaped headwall and irrigation ditch at the landside (LS) toe. (24-inch corrugated metal irrigation discharge pipe through the levee retained under Permit No. 8510, 1972 - John Clauss Jr. et al.). [Additional Reference(s): DWR Levee Log, 1990. USACE Sacramento O&M Manual 128, March 1960, (HLM 17.14)]. FS Date: 1/14/2014

WS view: CMP riser with slide gate on levee slope.

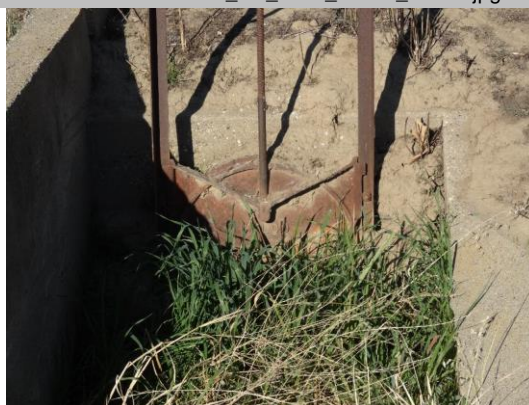
Photo 3 of 3 : UCIP_SP_2018_28489_52477.jpg

LS view: U type concrete headwall with slide gate on levee toe.

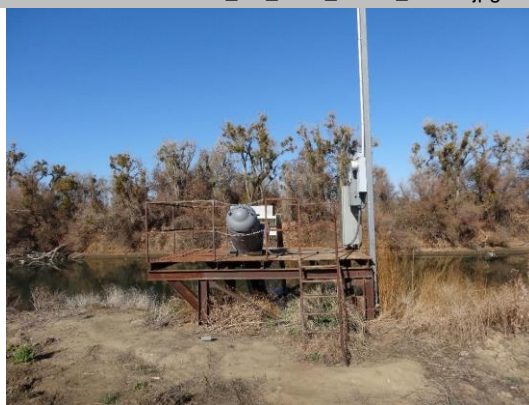
Photo 1 of 3 : UCIP_SP_2018_28490_52485.jpg

Comment Code						
Inspector Comment						
FS_ID:28490 DS_ID:20066 EP_NO: 1739 Repair Type: Non-Urgent Crossing Status: Found UCIP Comments: Most of the pipe exposed on levee slope.Pipe leakage repaired recently.Siphon breaker requires protection. FIELD_STRUCT_DESC: 20-inch welded steel irrigation discharge pipe through the levee, 5.5 feet below the crown. Slant pump mounted on a steel structure on the waterside (WS). Siphon breaker on the landside (LS) slope. Pipe discharges into a 6-foot by 5.5-foot, outside dimensions, concrete distribution box and irrigation ditch at the LS toe. Fish screen added in 2011. (Installation of a slant pump and a discharge pipe through the levee authorized under Permit No. 1739, 1953 - John Clauss. Installation of a fish screen authorized under Permit No. 18678, [permit missing], [RM 102.50]). [Additional Reference(s): DWR Levee Log, 2005. USACE Sacramento O&M Manual 128, March 1960, (HLM 17.45)]. FS Date: 1/14/2014

WS view: slant pump on steel platform on levee berm.

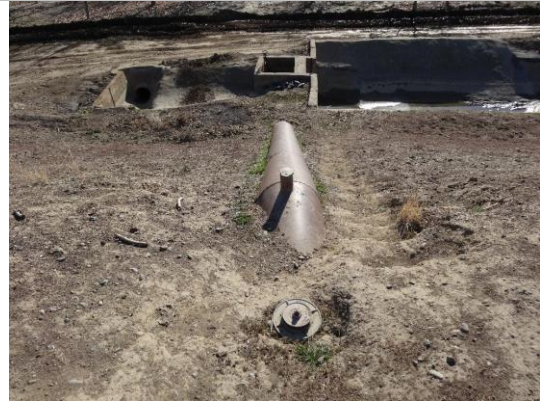
Photo 2 of 3 : UCIP_SP_2018_28490_52484.jpg

LS view: siphon breaker (bottom) without protection, exposed pipe on levee slope, and distribution box on levee toe.

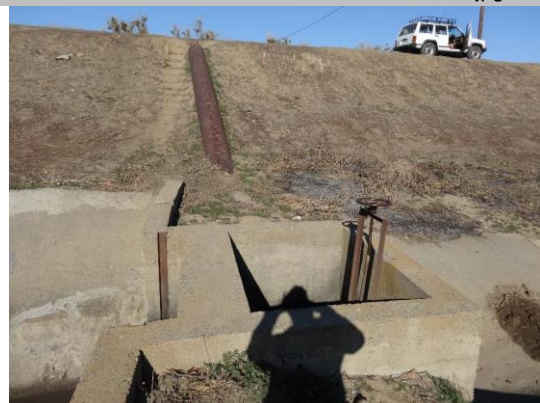
Photo 3 of 3 : UCIP_SP_2018_28490_52483.jpg

LS view: exposed pipe on levee slope, and concrete distribution box on levee toe.

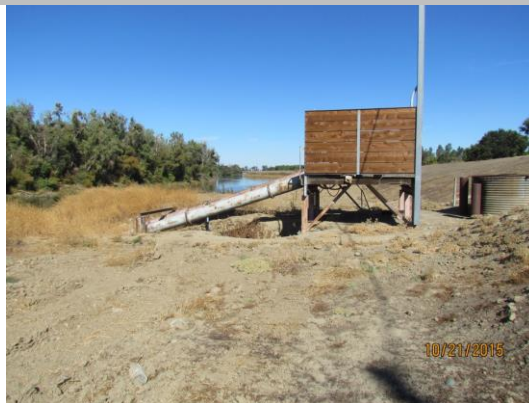
Photo 1 of 3 : SP_2018_RD1500_189_121_20180306_00065.jpg

Perspective view of the pump on the waterward side of the levee looking upstream. Fall 2015.

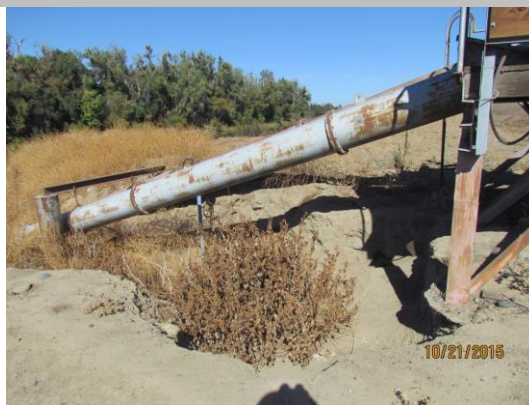
Photo 2 of 3 : SP_2018_RD1500_189_121_20180306_00066.jpg

There is erosion underneath the pipe on the waterward berm area. Fall 2015.

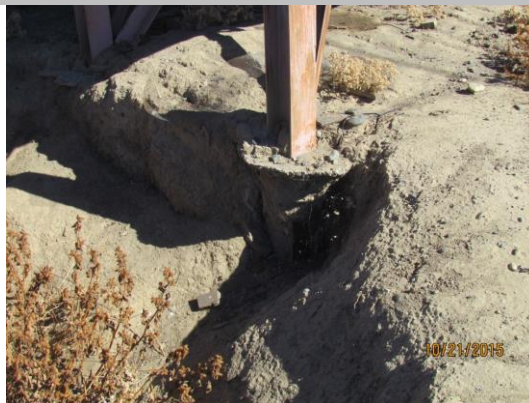
Photo 3 of 3 : SP_2018_RD1500_189_121_20180306_00067.jpg

The concrete for the base stand has been exposed due to erosion.

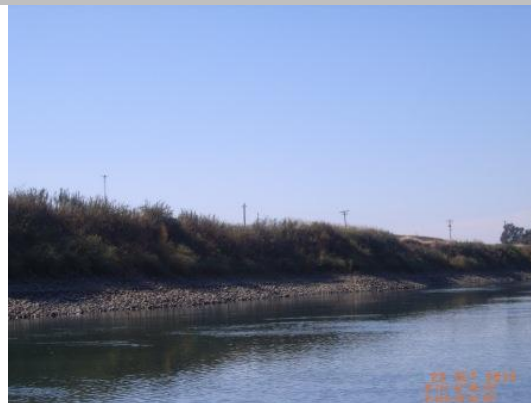
Photo 1 of 1 : SP_2018_RD1500_189_13_20180306_00013.jpg

LM Start	18.38	Rating **	A/W	Issue No.	13
LM End	19.06	Issue Type +	Ma	Location *	WS
Category	Supplemental			GPS Latitude/Longitude	
				Start	End
Item	2015 USACE Erosion Survey, DRAFT			38.901337 °	38.902721 °
				-121.801175 °	-121.790677 °
DWR ID	DWR_RD1500_01_s_2016_13				
Comment Code					
Inspector Comment					
1997 - Pocket failures of cobble revetment toe; scallops of rock loss along the bank; irregular bankline developing. 2001 - Small scallops in the toe of the berm. 2005 - Still multiple erosion pockets in the toe. 2006 - Two new small slumps. 2011 - Old cobble continue to fail causing minor slumping. 2012 - Portions of site appears to be stabilizing. 2015: No observed changes. [2015 Site ID: SAC_104-0_L]

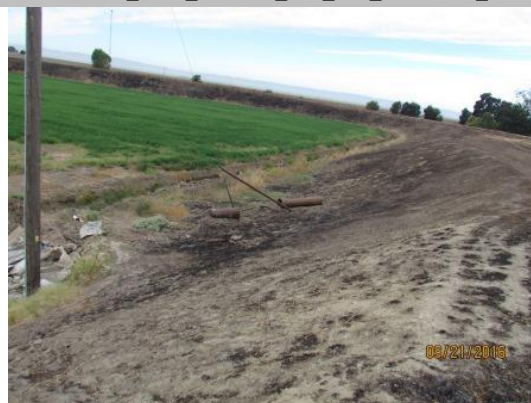
Photo 1 of 1 : SP_2018_RD1500_189_113_20180306_00057.jpg

LM Start	18.39	Rating **	M	Issue No.	113
LM End	18.39	Issue Type +	En	Location *	LS
Category	Earthen Levee			GPS Latitude/Longitude	
				Start	End
Item	Encroachments			38.901022 °	38.901022 °
				-121.801150 °	-121.801150 °
DWR ID	DWR_RD1500_01_f_2016_113				
Comment Code					
DE : Debris					
Inspector Comment

Debris on landside slope of the levee. Fall 2016.

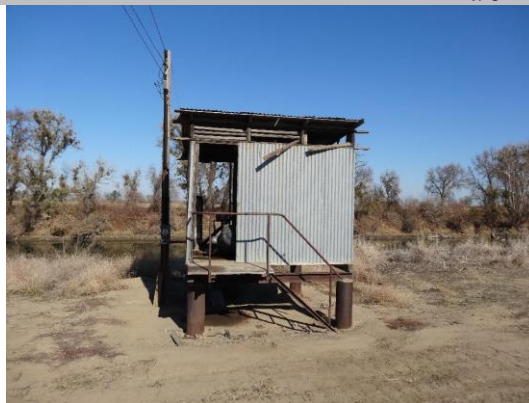
Photo 1 of 3 : UCIP_SP_2018_28505_52517.jpg

Comment Code						
Inspector Comment						
FS_ID:28505 DS_ID:20068 EP_NO: 2425 Repair Type: Non-Urgent Crossing Status: Found UCIP Comments: Concrete pad on both sides of the levee shoulders.Oil leaks from pump set. FIELD_STRUCT_DESC: 14-inch steel irrigation discharge pipe through the levee, 3 feet below the crown. Two concrete cutoff walls. Slant pump in a corrugated metal pump house on a steel structure on the bank. Meter pole on the slope. Water meter installed on the pipe on the waterside (WS) slope. Siphon breaker on the landside (LS) shoulder. Pipe discharges into a 36-inch, inside diameter, concrete standpipe at the LS toe. (Installation of a pumping plant and discharge pipe authorized under Permit No. 2425, 1956 - Glenn J. Hiatt, [RM 103.66]). [Additional Reference(s): DWR Levee Log, 2005. USACE Sacramento O&M Manual 128, March 1960, (HLM 18.60)]. FS Date: 1/14/2014

WS view: slant pump in CM shed on levee berm. Oil leaks from the pump.

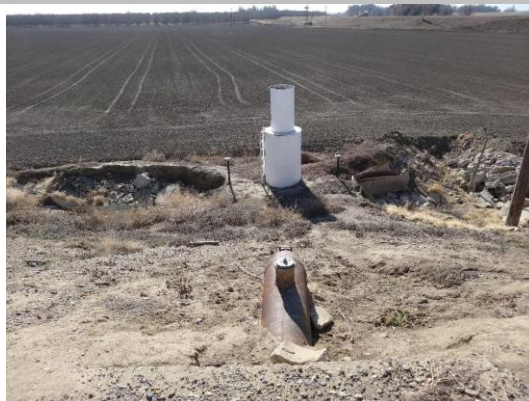
Photo 2 of 3 : UCIP_SP_2018_28505_52516.jpg

LS view: siphon breaker (bottom) on exposed steel pipe on levee slope and steel stand pipe (top) on levee toe.
